**PHASE II ENVIRONMENTAL SITE ASSESSMENT
THE BELL BUILDING
1605 CENTRAL AVENUE
CHEYENNE, LARAMIE COUNTY, WYOMING
REVISION 1**

Date Prepared	February 2019
TDD No.	0003/1810-20
Document Control No.	W0652.1B.01846
Contract No.	EP-S8-13-01
U.S. EPA Work Assignment Manager	Ted Lanzano

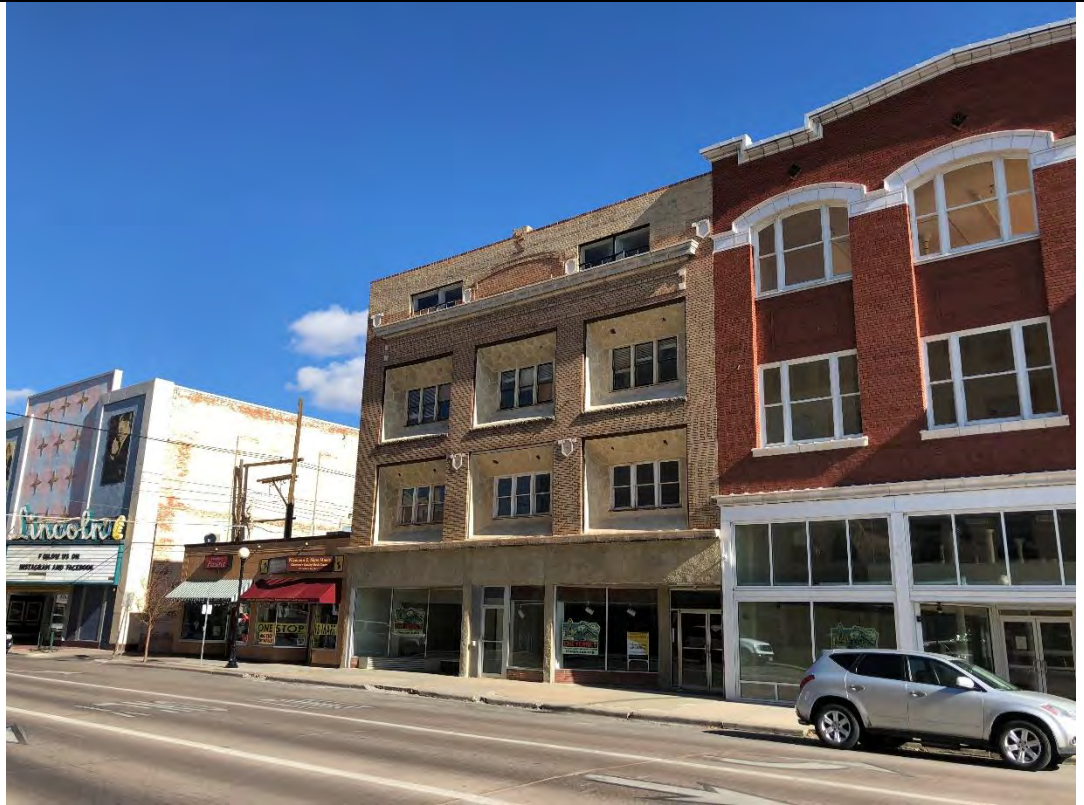
Photo No. 1	Date: 10/31/2018
Photo Coordinates	
Lat	41.133228
Long	-104.814286
Direction Photo Taken: 24.7589111328125	
Description: Facade of the Bell Building with LBP on windows and ACM window glazing.

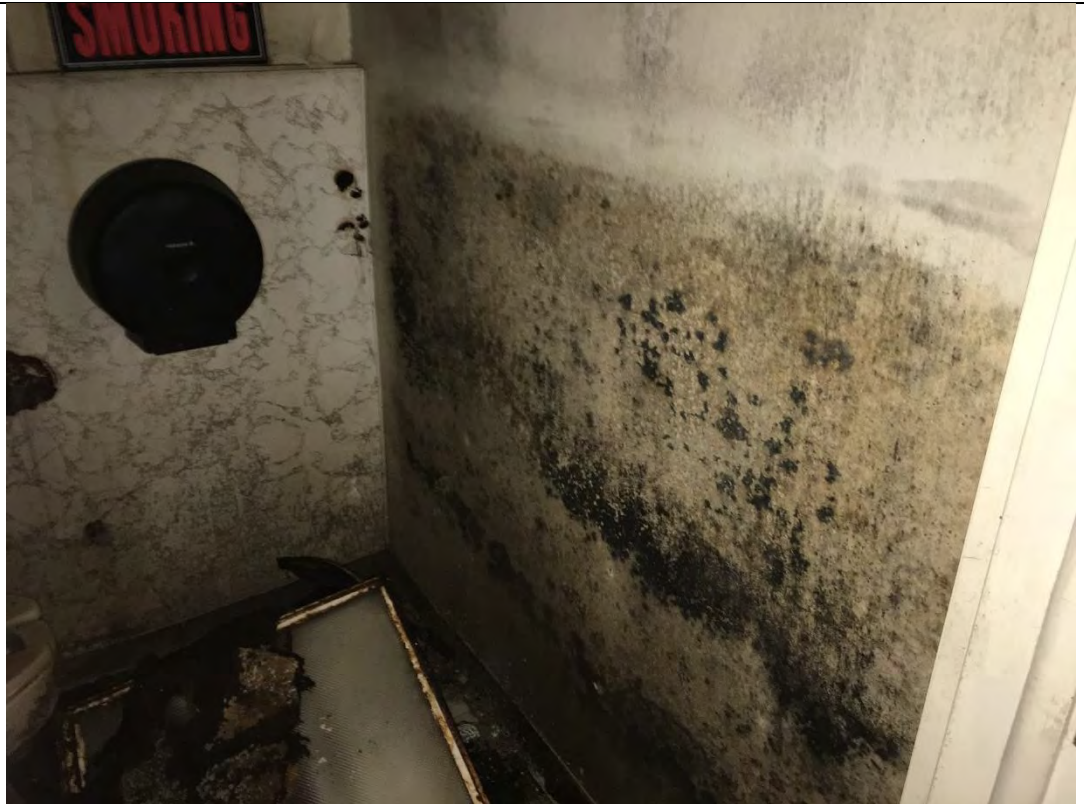
Photo No. 3	Date: 08/24/2017
Photo Coordinates	
Lat	41.133553
Long	-104.8142
Direction Photo Taken: 194.029069767442	
Description: Mold observed on the main level of the building.

- Mercury devices and PCB-containing equipment should be removed and properly disposed of during renovation activities.
- Mold/mildew should be remediated by a certified restoration company. Clearance air samples are recommended to verify proficiency of the removal methods.

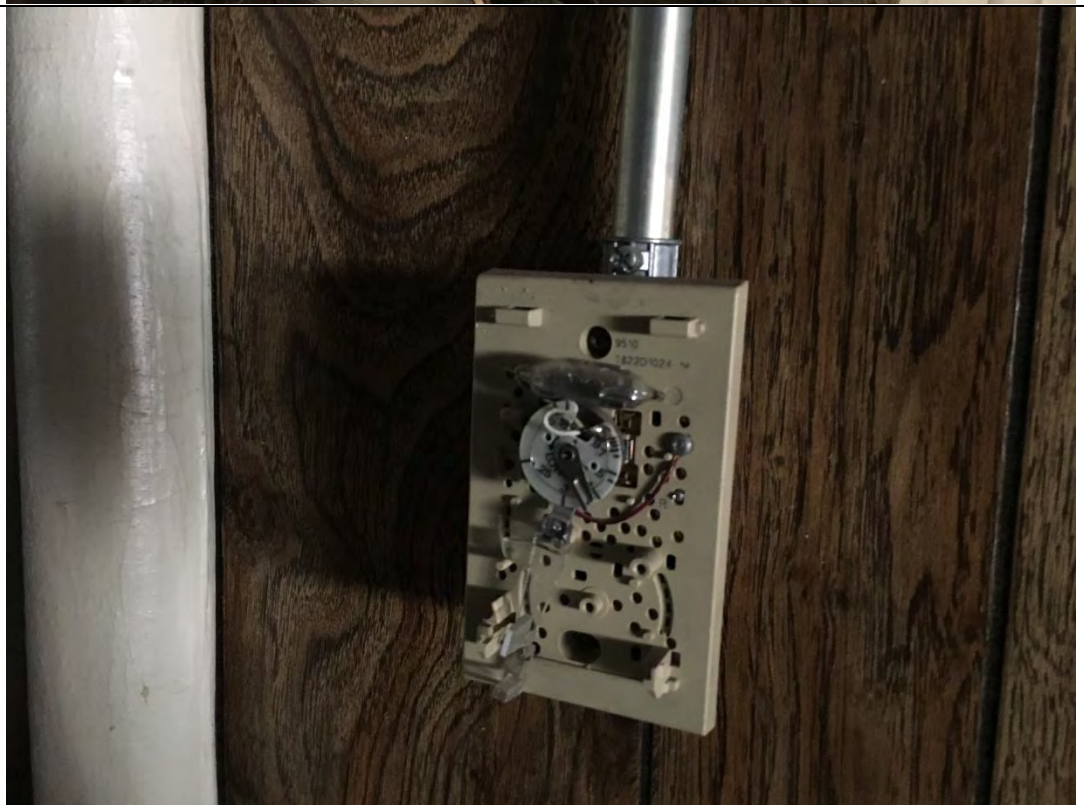
- Two mercury switches were observed in the main level showroom. No additional mercury switches were observed.
- Large areas of potential mold and mildew staining were observed throughout the building, with the exception of the basement.

Photo No. 4	Date: 08/24/2017
Photo Coordinates	
Lat	41.133556
Long	-104.813758
Direction Photo Taken: 123.17494600432	
Description: Mercury thermostat switch observed on the main level of the building.

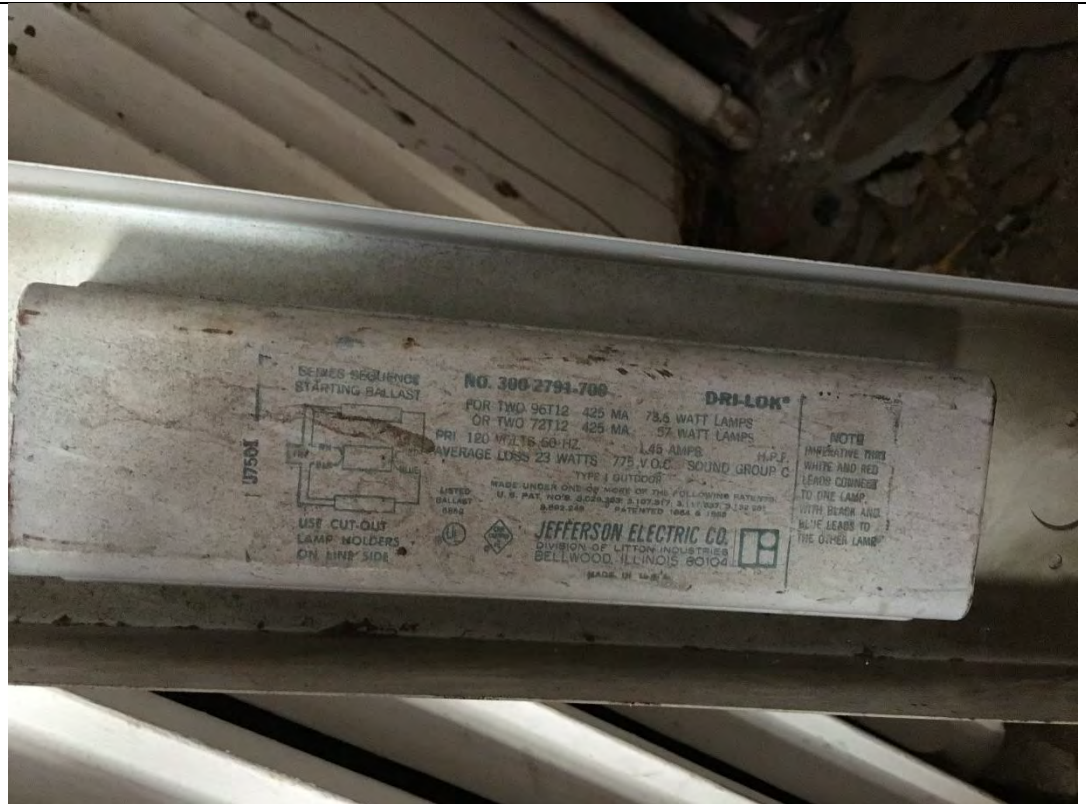
- Light fixtures in the first, second, third, and fourth floors were primarily fluorescent fixtures. None of the light fixtures observed in the building appeared to be leaking fluids. Ballasts without a “No-PCBs” label were observed and are assumed to contain PCBs.

Photo No. 5	Date: 08/24/2017
Photo Coordinates	
Lat	41.133678
Long	-104.814422
Direction Photo Taken: 354.902040816327	
Description: PCB ballast observed in the building.

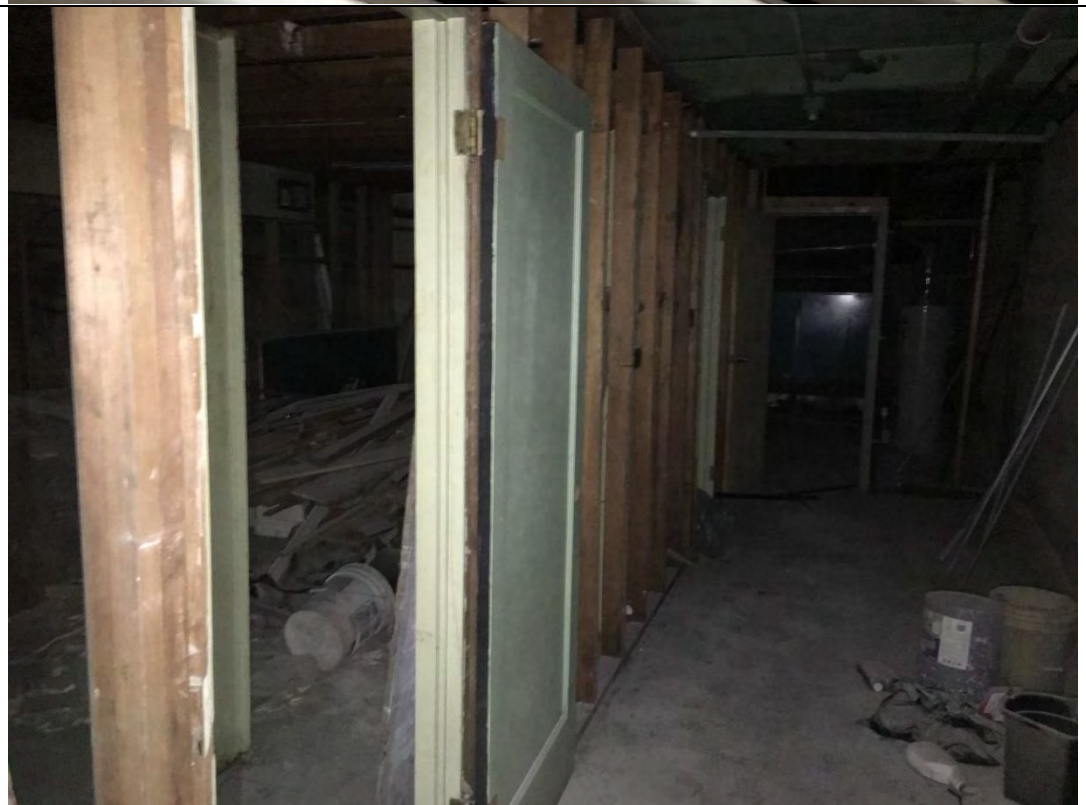
Photo No. 6	Date: 08/24/2017
Photo Coordinates	
Lat	41.13345
Long	-104.814431
Direction Photo Taken: 309.235576923077	
Description: Basement of the building with ACM floor tiles.

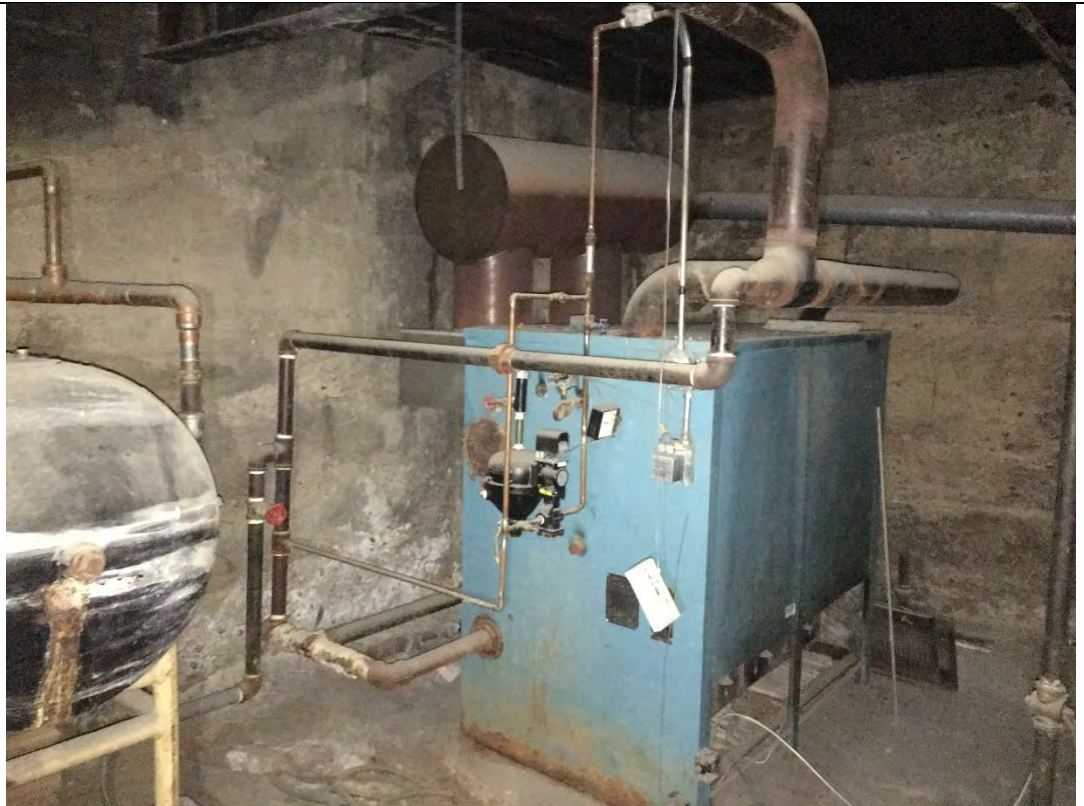
Photo No. 7	Date: 08/24/2017
Photo Coordinates	
Lat	41.133533
Long	-104.813981
Direction Photo Taken: 25.5047923322684	
Description: Furnace in the basement with an ACM gasket.

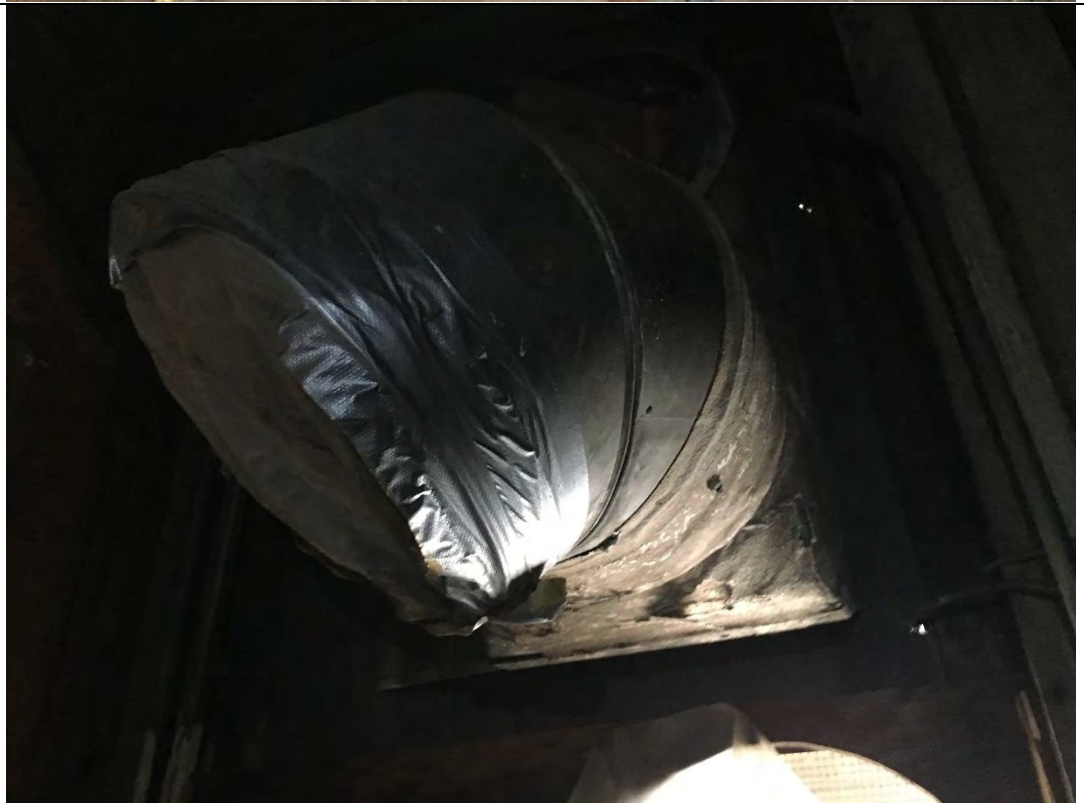
Photo No. 8	Date: 08/24/2017
Photo Coordinates	
Lat	41.133633
Long	-104.813911
Direction Photo Taken: 65.6454183266932	
Description: ACM on a duct elbow on the 2 nd floor.

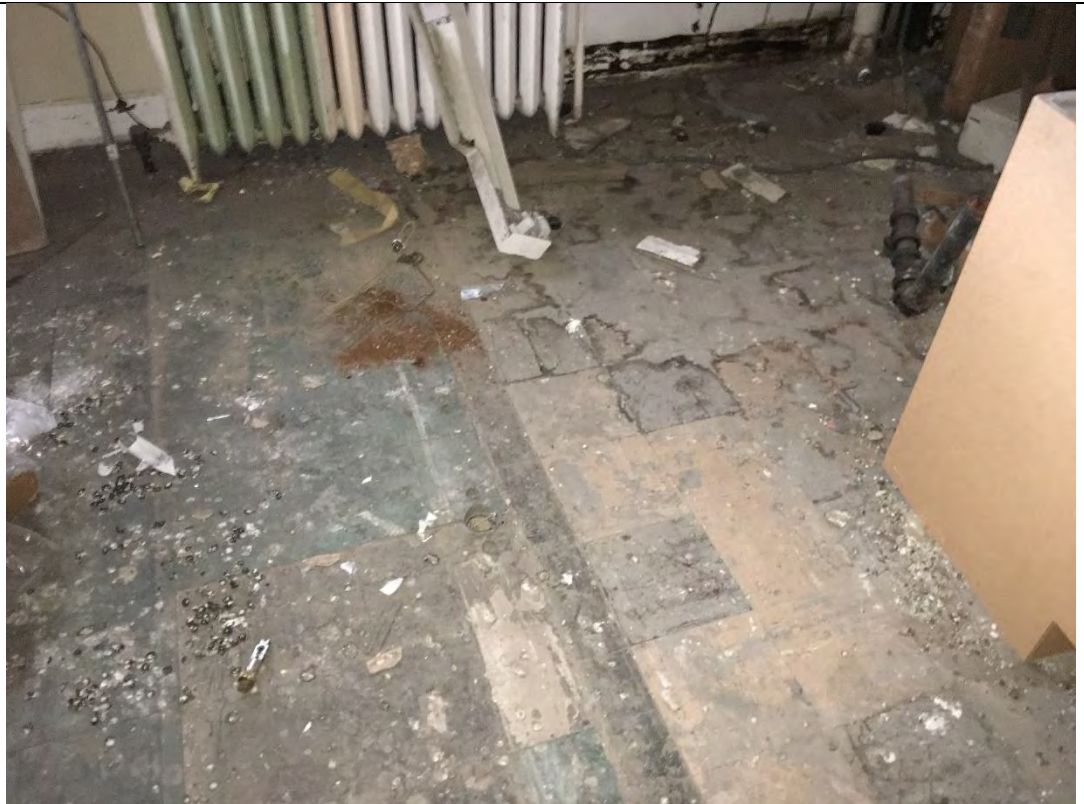
Photo No. 9	Date: 08/24/2017
Photo Coordinates	
Lat	41.133811
Long	-104.814353
Direction Photo Taken: 334.707547169811	
Description: ACM floor tiles observed throughout the building.

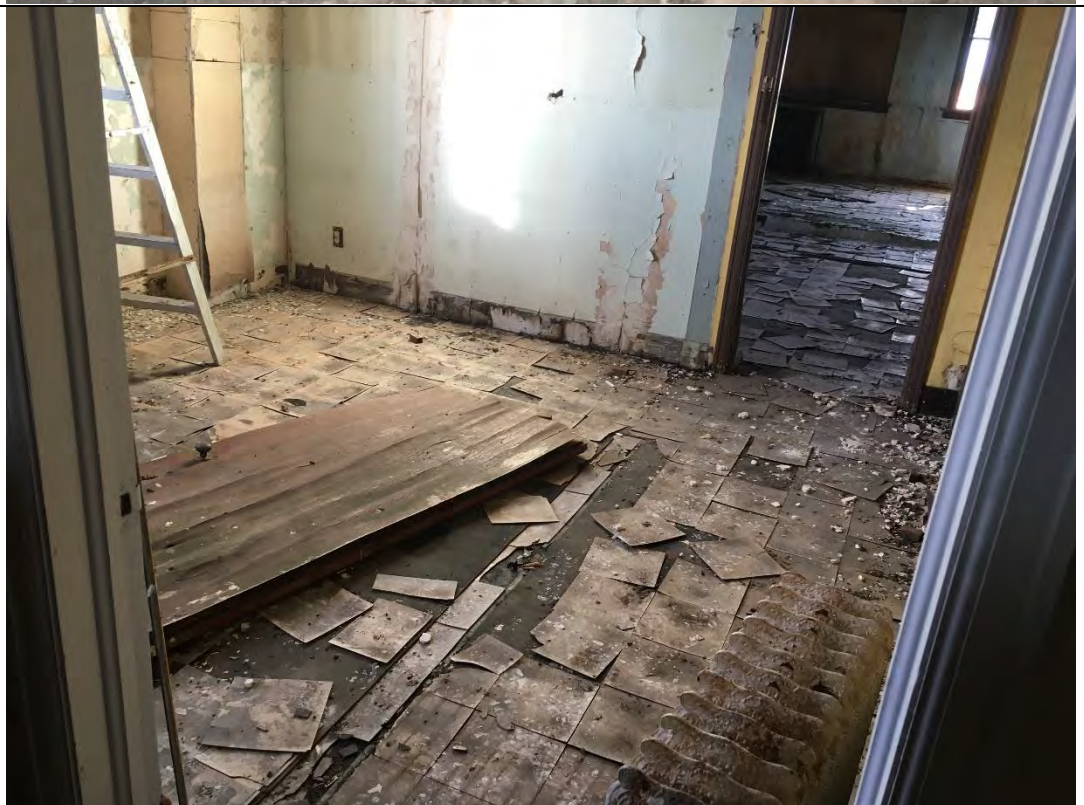
Photo No. 10	Date: 08/24/2017
Photo Coordinates	
Lat	41.133594
Long	-104.814383
Direction Photo Taken: 34.1547231270358	
Description: ACM floor tiles observed throughout the building.

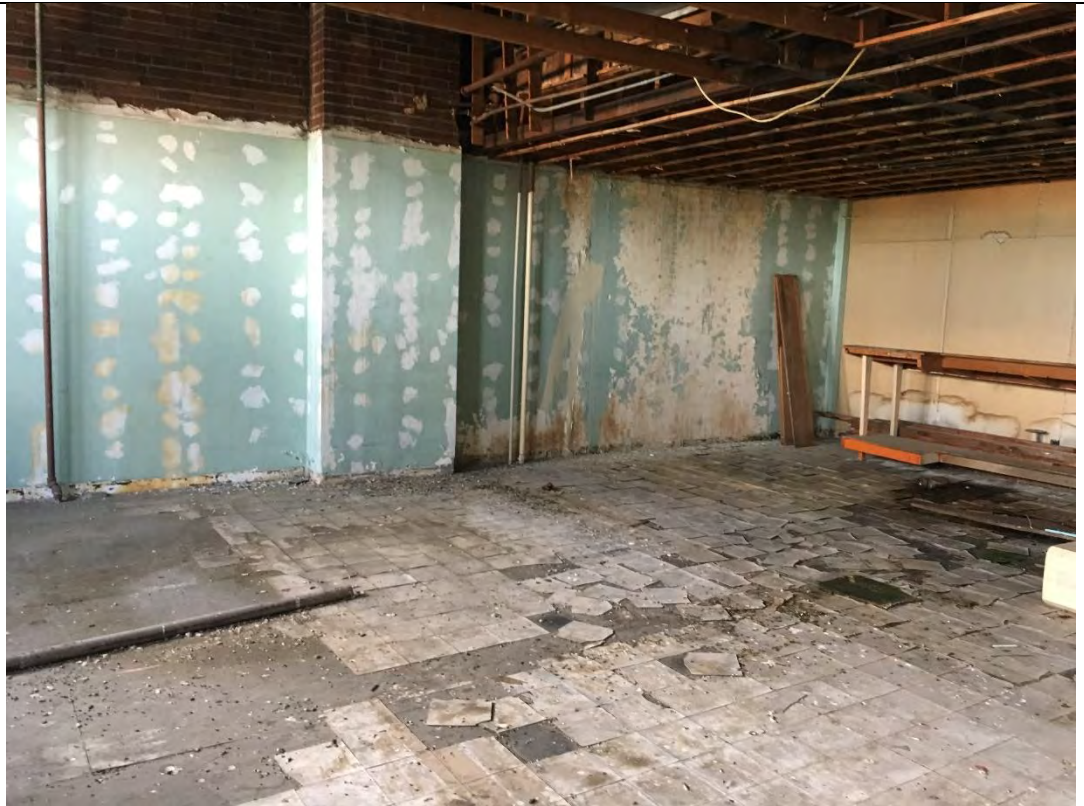
Photo No. 11	Date: 08/24/2017
Photo Coordinates	
Lat	41.133294
Long	-104.814019
Direction Photo Taken: 198.468965517241	
Description: ACM floor tiles present on the 3 rd floor.

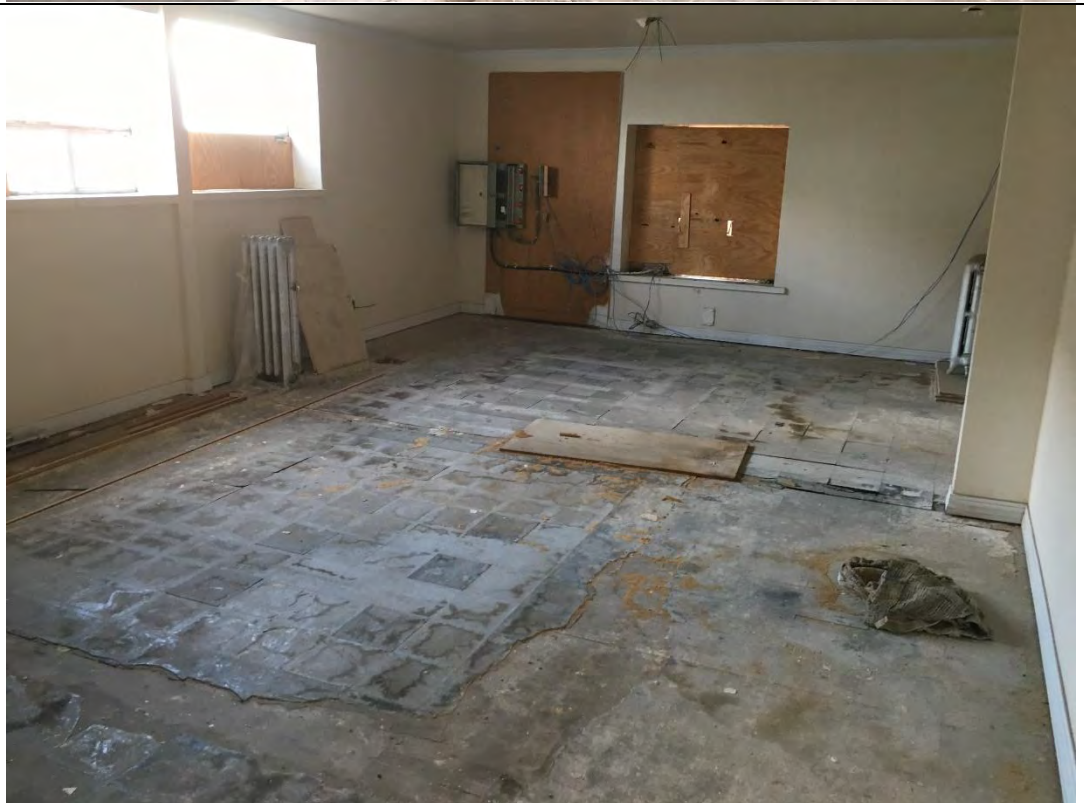
Photo No. 12	Date: 08/24/2017
Photo Coordinates	
Lat	41.133503
Long	-104.814261
Direction Photo Taken: 275.973384030418	
Description: ACM floor tiles and drywall texture on the 4 th floor.

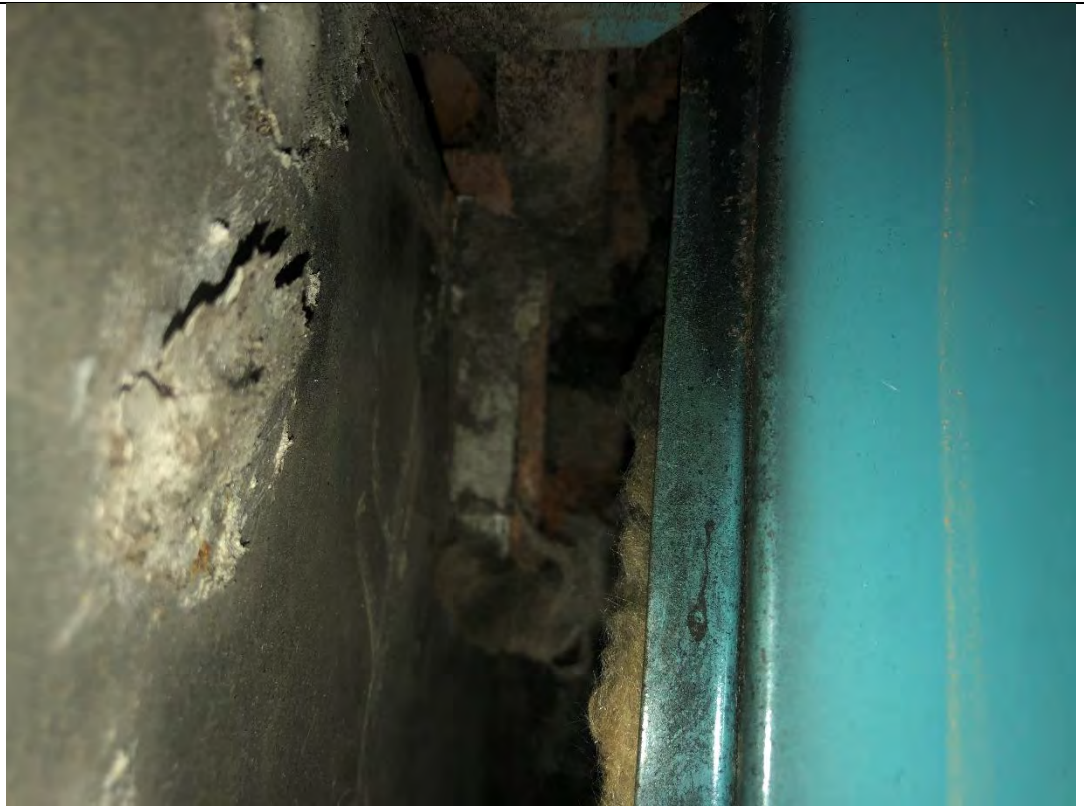
Photo No. 13	Date: 11/08/2018
Photo Coordinates	
Lat	41.133461
Long	-104.814217
Direction Photo Taken: 160.564056297366	
Description: ACM gasket present in the furnace in the basement.

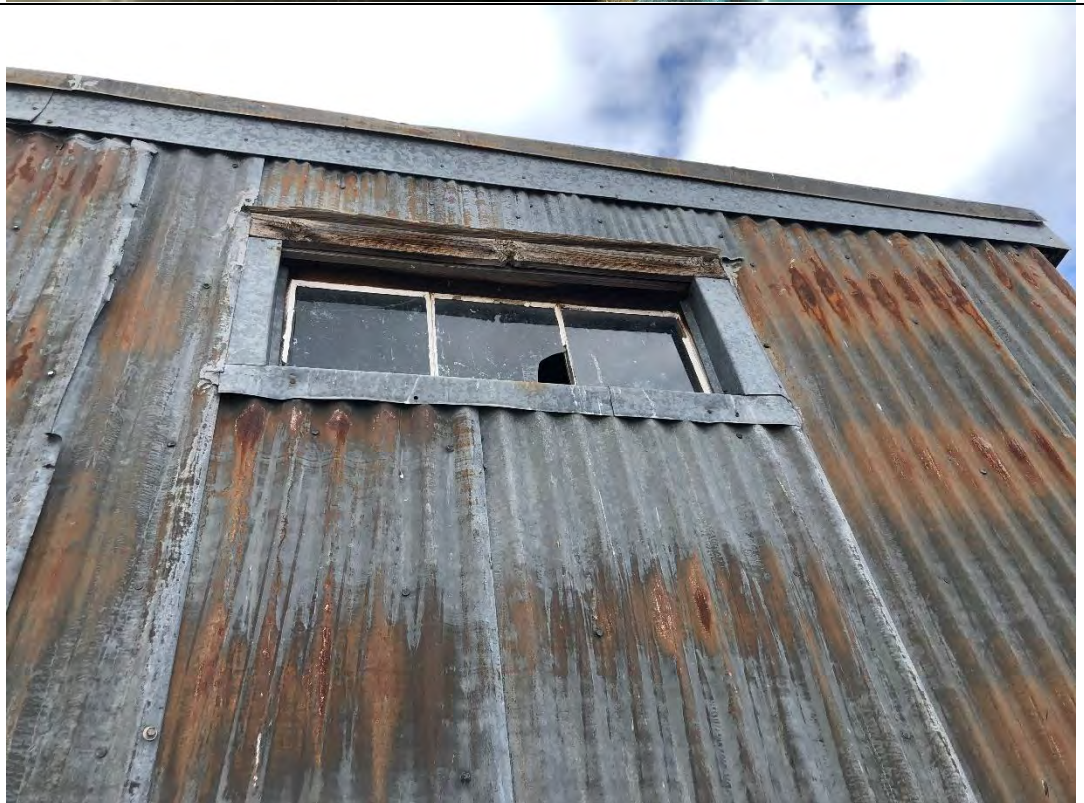
Photo No. 14	Date: 11/08/2018
Photo Coordinates	
Lat	41.133494
Long	-104.814142
Direction Photo Taken: 347.432311977716	
Description: Assumed ACM window glazing on the elevator shaft on the roof.

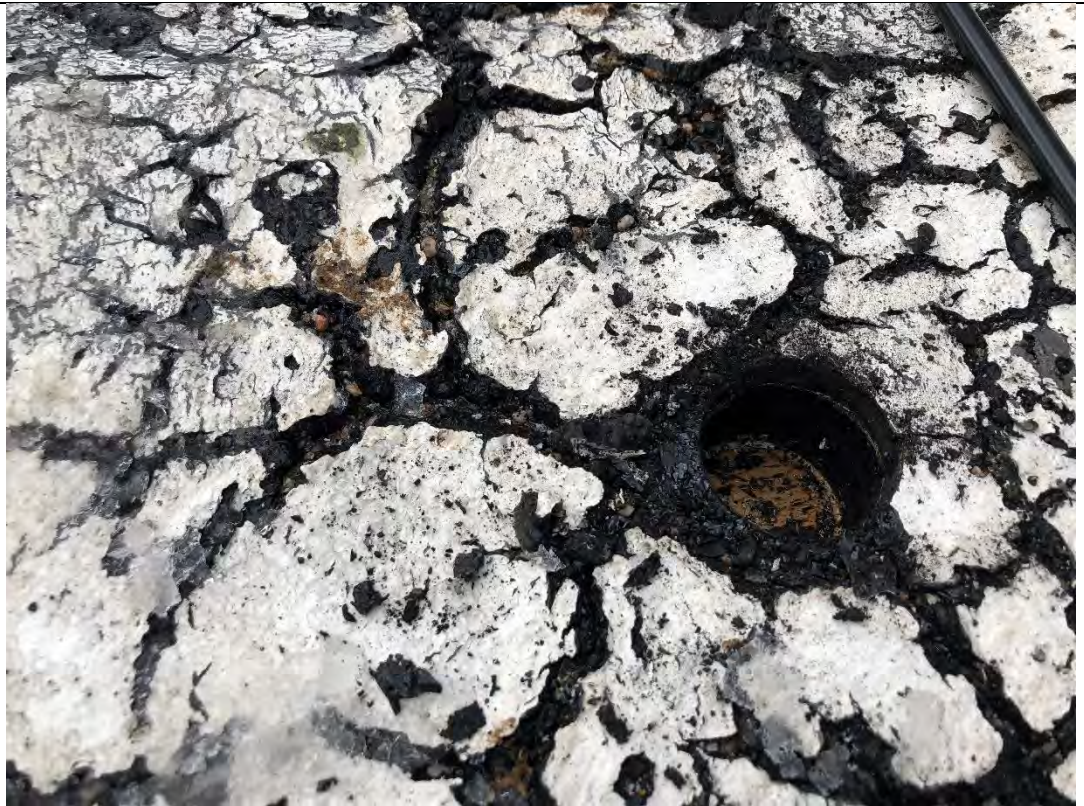
Photo No. 15	Date: 11/08/2018
Photo Coordinates	
Lat	41.133503
Long	-104.814125
Direction Photo Taken: 258.336120401338	
Description: Roof core sample collected and identified as ACM.
